Technical Report No. 64.190.12.00108.01B

Client:	Eastern Sports Industrial Co.,Ltd Address: No.2 Wayaobei Industrial Zone,Wulian Community,Longcheng Street, Longgang District,Shenzhen,China
Test subject:	Product: STAGE Type: ESIASSP4x4, ESIASSP4x8
Test specification:	According to the client' s requirements. Details see Clause 3.
Purpose of examination:	Test according to the test specification.
Test result:	Details see the test result in Clause 3.

Manufacturer’ s specification for intended use,
STAGE

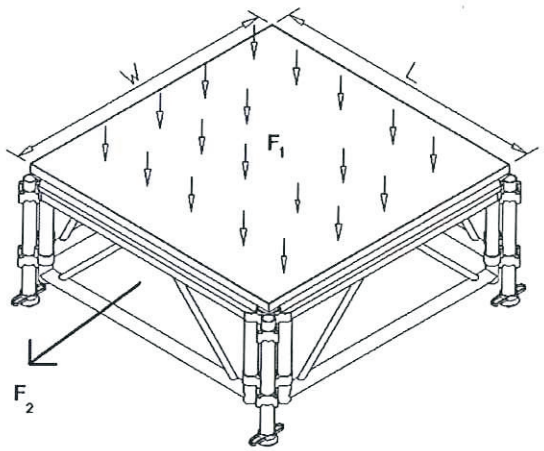
Figure 1	No visible damage was found after test.	P
